INSPECTION REPORT

SAMPLE REPORT

Prepared for: SAMPLE REPORT Inspection Date: SAMPLE REPORT Prepared by: James Stinson

Handy Home Inspection 10410 Whitmore Lake Brighton, MI 48116 248.756.5081

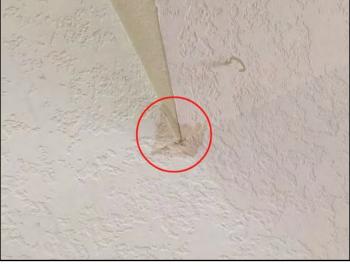
1. Condition: • Leak

Implication(s): Chance of water damage to contents, finishes and/or structure

Location: Third Floor

Task: Replace

Time: Immediate

Cost: Major

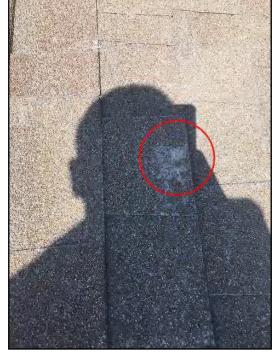
2. Condition: • Old, worn out

Implication(s): Chance of water damage to contents, finishes and/or structure Location: Various Task: replace Time: Immediate Cost: Major

2. Old, worn out

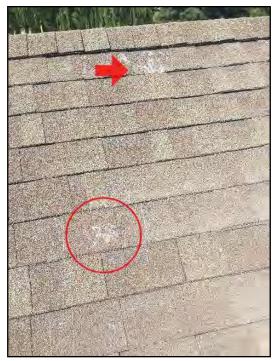
4. Old, worn out

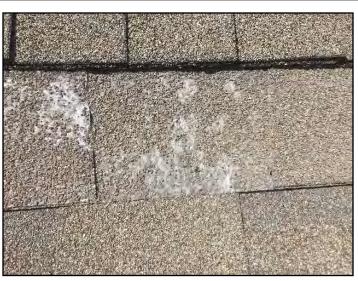
3. Old, worn out

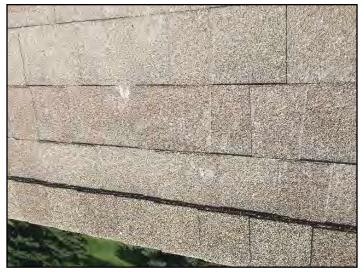
5. Old, worn out

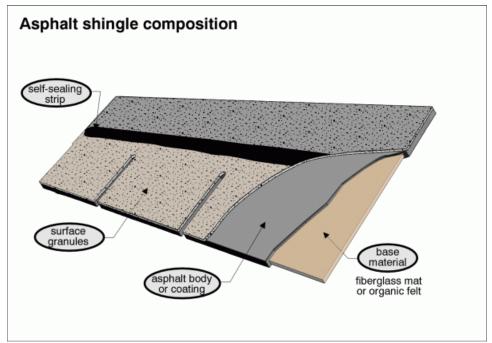
3. Condition: • Granule loss

Implication(s): Chance of water damage to contents, finishes and/or structure

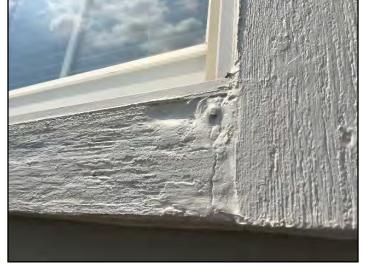
EXTER	IOR						www.handyhoi	Report meinspectionofm	No. 1055
SUMMARY	ROOFING	EXTERIOR	STRUCTURE	ELECTRICAL	HEATING	COOLING	INSULATION	PLUMBING	INTERIOR
REFERENCE									
Recomr	nendatic	ons							
WALLS \ T 4. Condition Implication Location: S Task: Repl Time: Disc	on: • Rot h(s): Chanc Second Floo ace		mage to con	tents, finishe	es and/or stru	ucture Mate	rial deteriorat	ion

20. Rot

21. Rot

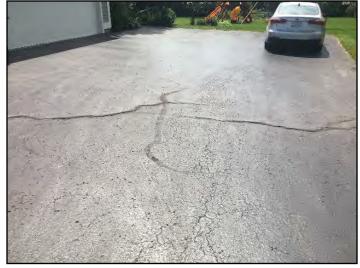
5. Condition: • <u>Cracked or damaged surfaces</u> Implication(s): Trip or fall hazard Task: Repair Time: Discretionary

23. Cracked or damaged surfaces

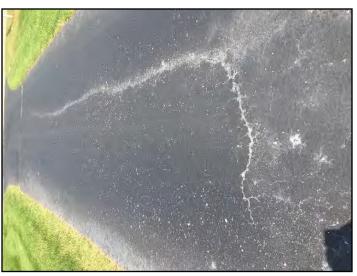
24. Cracked or damaged surfaces

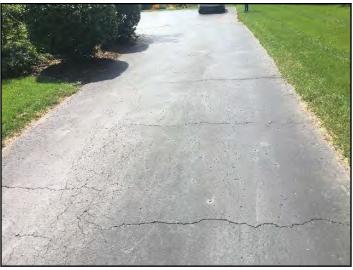
25. Cracked or damaged surfaces

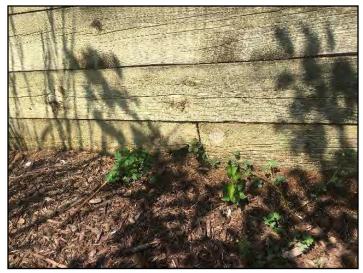
6. Condition: • Rot or insect damage
Implication(s): Weakened structure | Chance of movement
Location: Various
Task: Further evaluation
Time: Immediate

26. Rot or insect damage

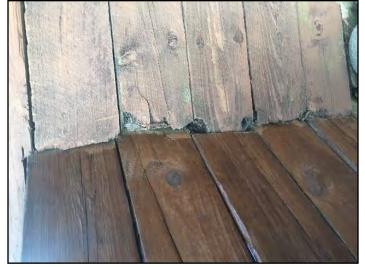
28. Rot or insect damage

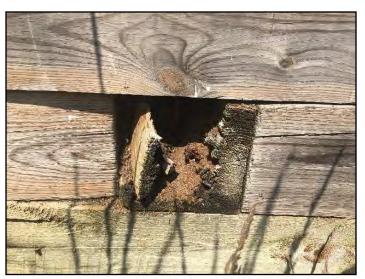
27. Rot or insect damage

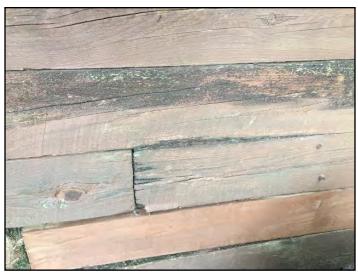
29. Rot or insect damage

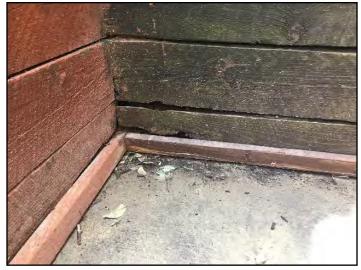
32. Rot or insect damage

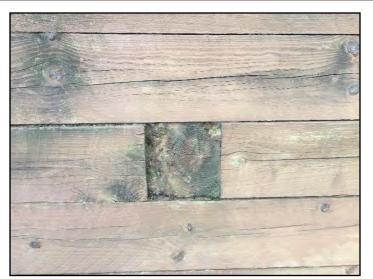
31. Rot or insect damage

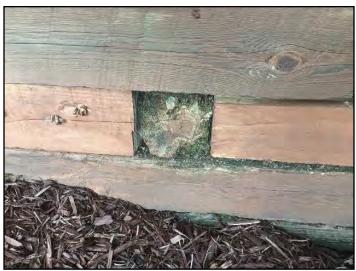
33. Rot or insect damage

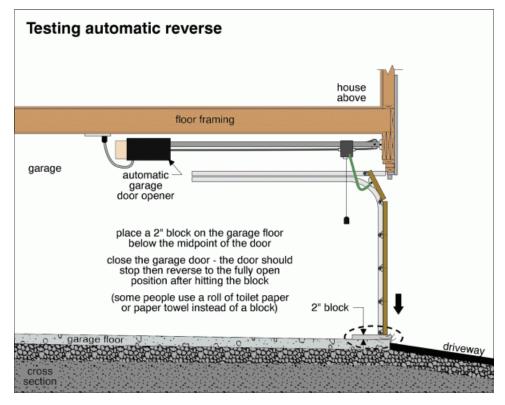
8. Condition: • Fails to auto reverse
Implication(s): Physical injury
Task: Repair
Time: Immediate

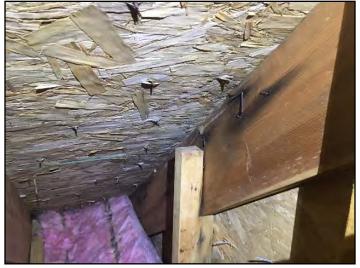
9. Condition: • <u>Water stains</u> Implication(s): Material deterioration Task: Further evaluation Time: Immediate

35. Water stains

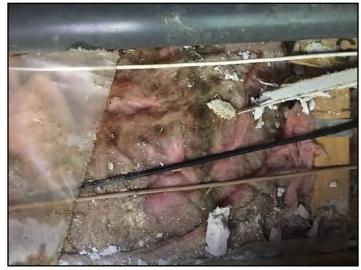
36. Water stains

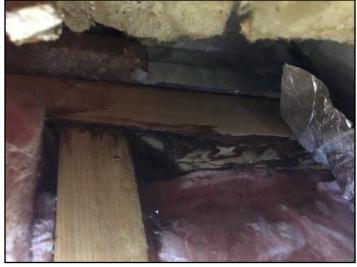
37. Water stains

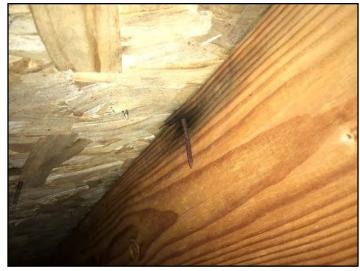
39. Water stains

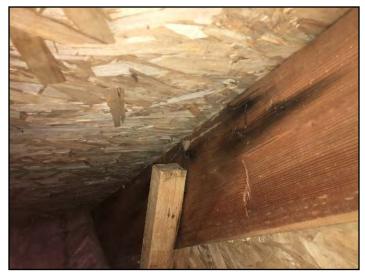
38. Water stains

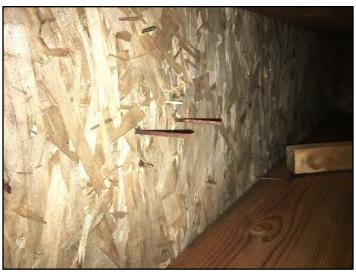
40. Water stains

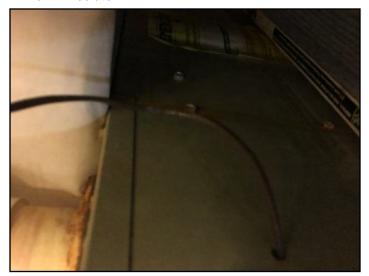
GAS FURNACE \ General 10. Condition: • Service furnace Task: Further evaluation Time: Immediate

42. Service furnace

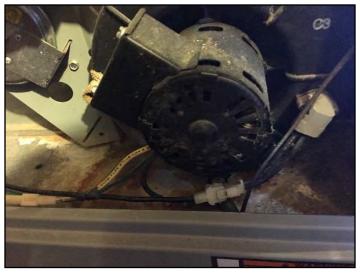
43. Service furnace

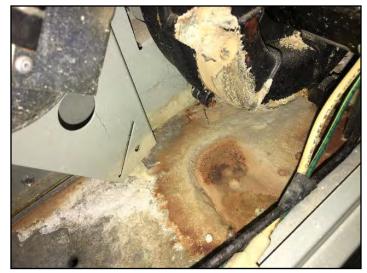
44. Service furnace

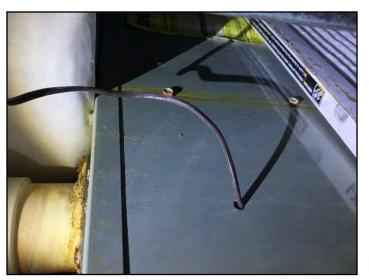
45. Service furnace

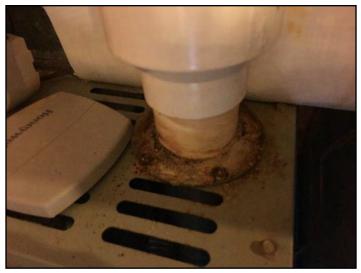
46. Service furnace

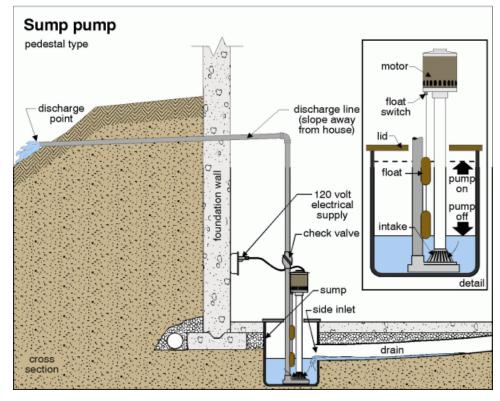
12. Condition: • Inoperative Implication(s): Chance of water damage to contents, finishes and/or structure

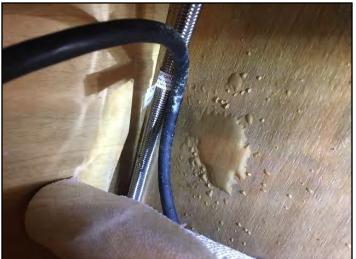
14. Condition: • Drip, leak

Implication(s): Chance of water damage to contents, finishes and/or structure

Location: Kitchen

47. Drip, leak

Task: Replace

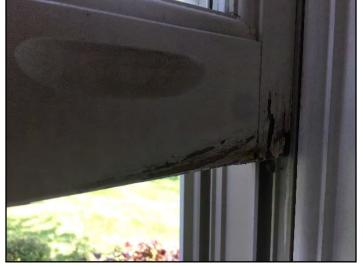
WINDOWS \ Frames 15. Condition: • Rot Implication(s): Chance of damage to structure | Material deterioration Location: Various Task: Replace Time: Discretionary Cost: Major

49. Rot

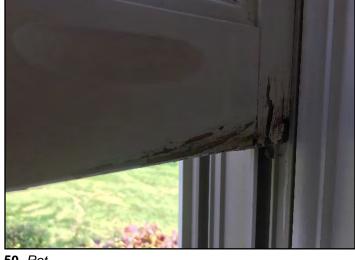
50. Rot

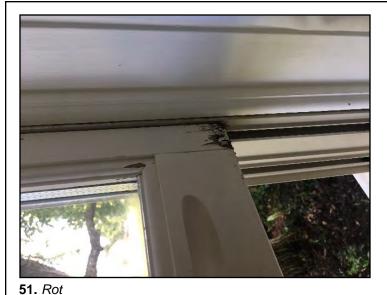
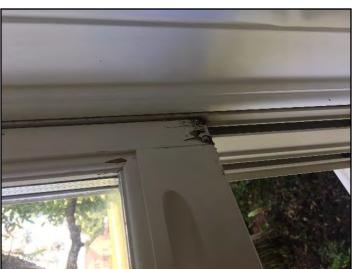
16. Condition: • Missing Implication(s): Increased heating and cooling costs | Reduced comfort Location: Various Task: Replace Time: Discretionary
